AMBIENT VIBRATION TESTS ON A BUILDING BEFORE AND AFTER THE 2012 EMILIA (ITALY) EARTHQUAKE

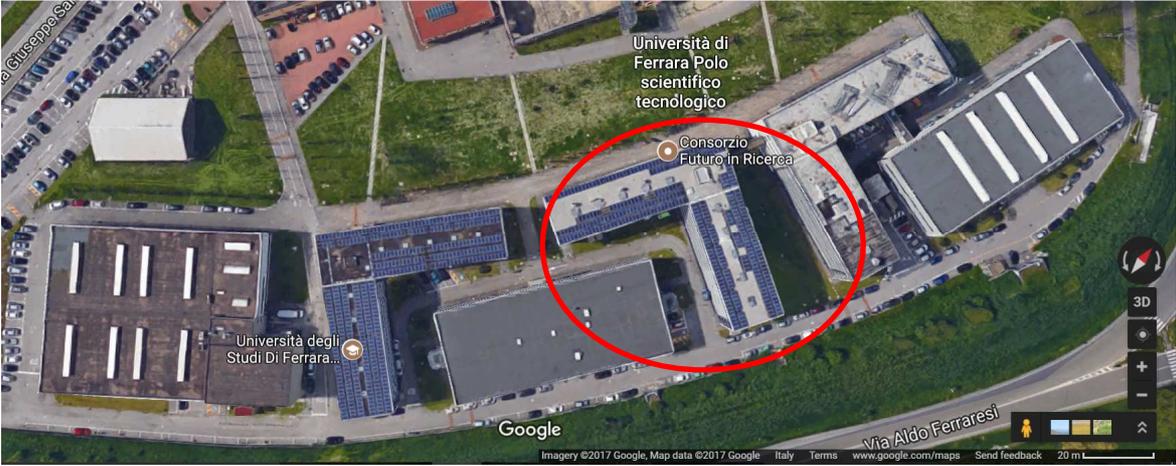
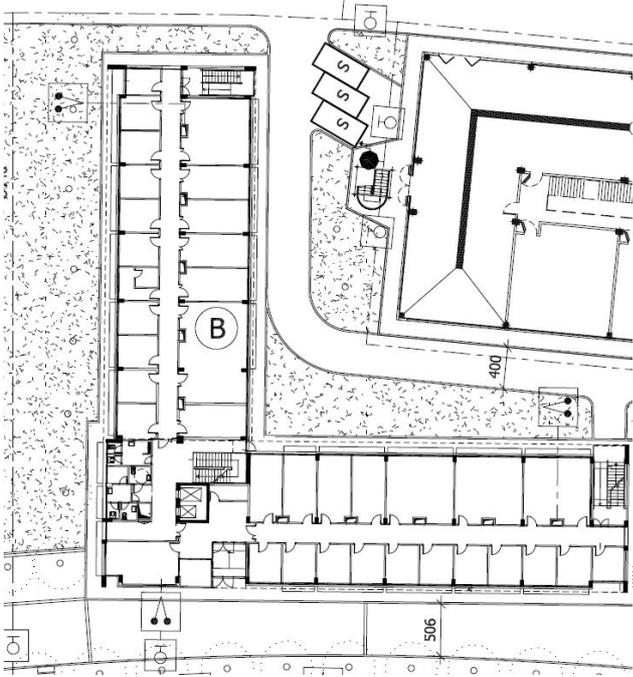
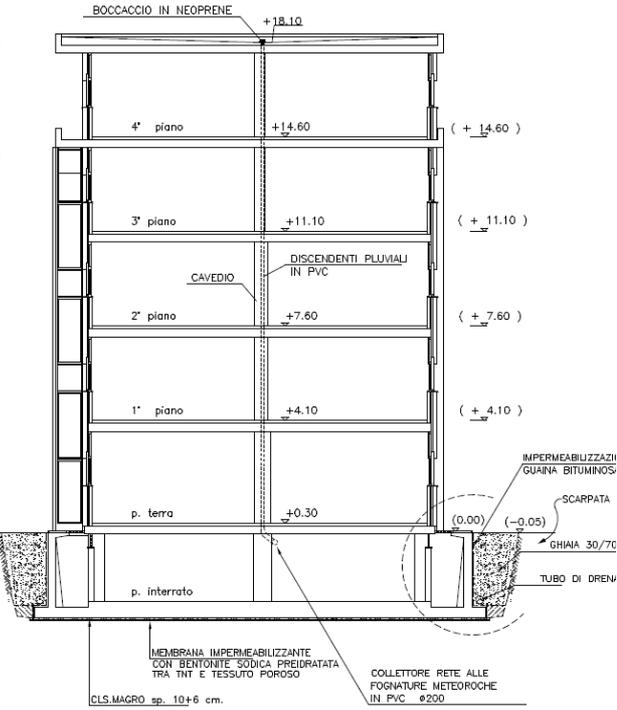
The investigated structure is a reinforced concrete frame, L-shaped, 5 floors building with a basement built in 2002. The two sides of the L, called from now on CFR (ConsorzioFuturo in Ricerca, 50m x 14.5 m) and SDT (Scienze Della Terra, 36 m x 14.5 m), are separated by a seismic joint (Figure 2). The building soil foundation is composed mainly of clay and silty clay sediments with some thin layers of organic clay that extends to 18 m depth. The average shear wave velocity in the first 30 m below the foundations placed the site in Class C ($V_s=200\pm 4$ m/s) according to the Italian Building Code (NTC08).

Figure 2 – (a) View on the scientific pole, red circle shows the investigated building; (b) floor layout and (c) side view of the investigated building.

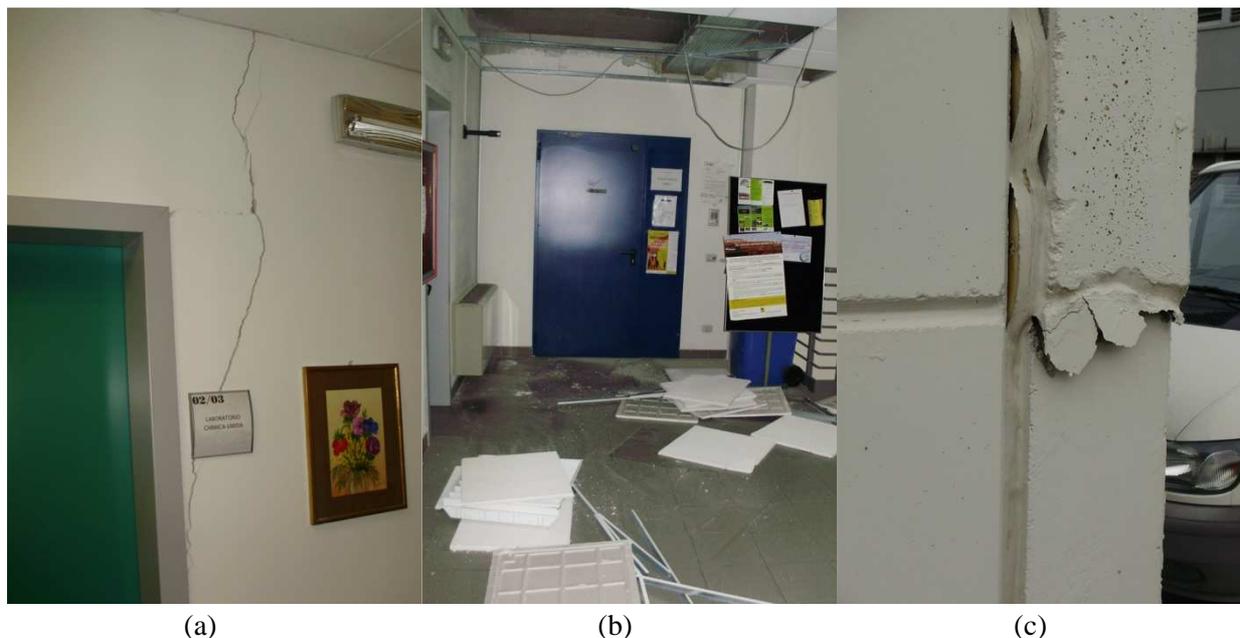
After the May 20 earthquake, the SDT side incurred damage effects presenting few diagonal cracks on the curtain walls of the ground floor and slightly of the first and second floors (Figure 3). On May 21, 2012, the day after the seismic event, a diagnostic inspection was performed according to the Civil Protection procedures (Baggio et al., 2014). In the inspection form, a slight damage (D1) on infill walls, extended to the 2/3 of the structure, and a medium to severe damage (D2-D3) on infill walls, extended to 1/3 of the structure, were reported. Additionally, other typology of non-structural damage was also collected particularly concerning plaster fall off and internal or external objects falling. Considering the inspection results, the building was declared temporarily not usable, until safety intervention took place, and parking outside the building was temporarily forbidden. Obviously, being a public building, with a high number of users (around a hundred), this resulted in a high level of inconvenience. The proposed intervention included repairing the infill walls and restoring the plasters as measures extended to a large part of the building. Moreover, as a high priority action, on the first and ground floors of the east side of the building it was prescribed to tie service ducts. An inspection on laboratories instruments (and to tie them on the wall) was also demanded. As prescribed, the damage to the walls was repaired through traditional construction works. Moreover, the doors of the

Figure 3 – Damage occurred on the SDT side of the investigated building. (a) curtain wall of the chemistry laboratory at the ground floor; (b) SDT side entrance at the second floor; (c) detail of one of the external wall.

two partition walls of the first floor of the SDT side (in the NW-SE direction) were reinforced with a metallic support. The ducts (130 cm wide) were also reinforced through metallic bars along all the floors, both in the CFR than in the SDT sides. The damage repair intervention was concluded in October 2012.

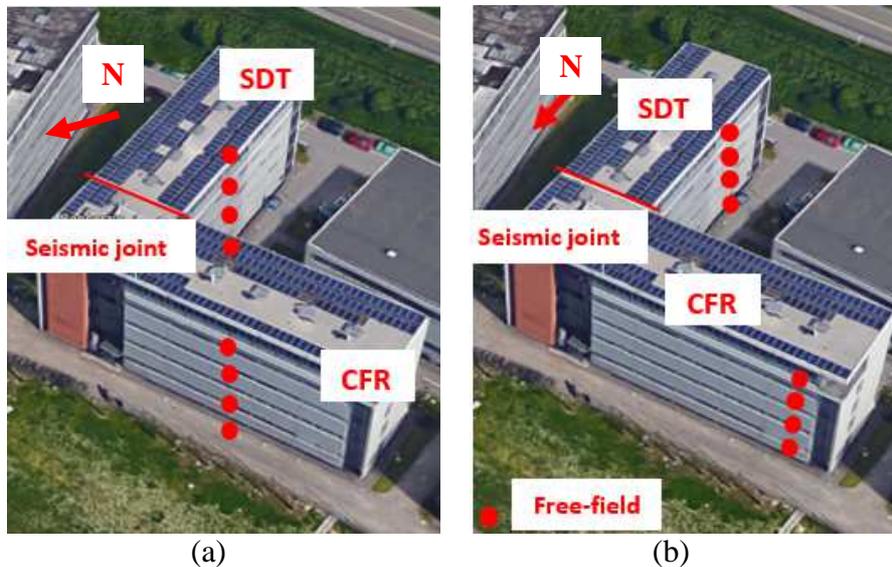
Figure 4 – View on the building, SDT and CFR sides, seismic joint position, position and direction of measurements for ambient vibration tests at each floor before and after the May 20 earthquake (a), and after the damage repair(b).

Figure 4 shows the position and the orientation of the instruments used for the ambient vibration tests. The HVNSRs have been estimated by dividing the signal into 5% overlapping windows of 20 s; each window was de-trended, tapered, padded, Fast Fourier Transformed and smoothed with triangular windows with a width equal to 5% of the central frequency. The Euclidean average was used to combine E-W and N-S components in the single horizontal (H) spectrum. Average vertical component spectra were obtained from the same procedure. For each HVNSR curve the relative ± 2 confidence interval is given. Some authors suggest that transient can affect estimates of fundamental frequency of soils, but in our previous experience a simple variation of amplitude never caused this problem, according to Parolai and Galiana-Merino (2006), Mucciarelli (2007) and Parolai et al. (2008).

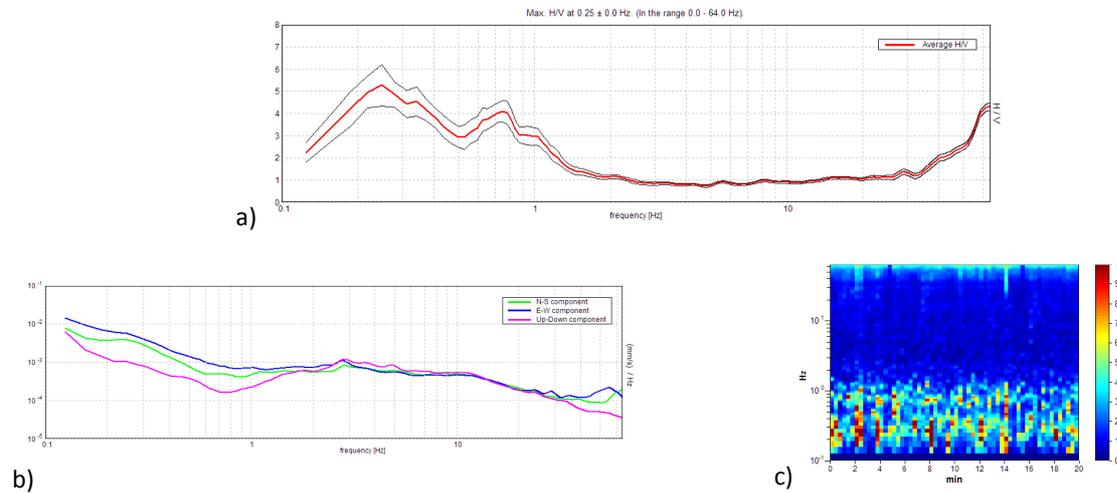
A test was performed on the free-field close to the building with the aim of estimating the soil resonance frequency. The results of free-field survey highlighted two peaks at low frequencies (0.75 Hz and 0.3 Hz) (Figure 5a), whose stratigraphic nature is confirmed by the geology of the area. The HVNSR applied to the records acquired in the basement of the building shows an identical curve.

Figure 5 – a) HVNSR curve, acquired on free-field conditions; b) three components Fourier spectra; c) Spectral stability (Time Frequency Analysis).

Microtremor HVNSR technique has been demonstrated to be effective in the assessment of the fundamental frequency response of the ground, in checking soil-structure interaction effects and to detect building fundamental modes (Gallipoli et al., 2004). In this approach, the vertical component of ambient vibrations is assumed as reference under the hypothesis that it is weakly affected by building dynamical properties. Under this assumption, if the structural frequency of the building is distinct enough from the soil's natural frequency, interpretation can be safely performed. This indeed was the case of our data-sets, where the natural frequencies of the soil were clearly identified at 0.75 Hz (Figure 5), while the structural frequency of the building was found to be higher (2-3 Hz).

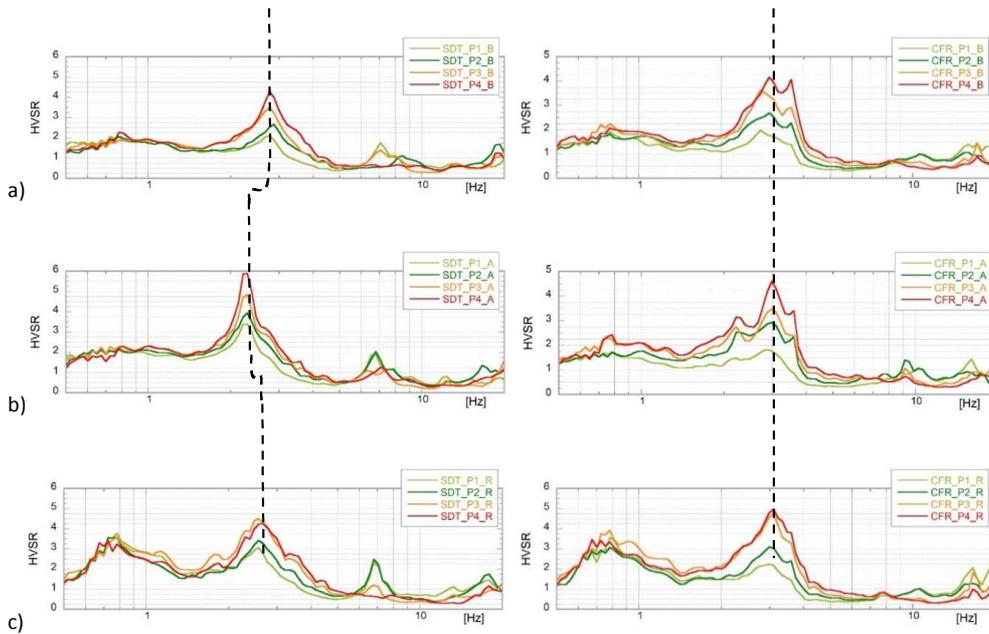
The HVNSR average functions acquired inside the building (Figure 6) show a significant and permanent drop of the SDT main frequency due to the damage. The frequency before the Mw 5.8 earthquake of October 20, 2016 is 2.9 Hz, after the earthquake it decreases at 2.2 Hz, and nearly recovering its position (approximately 2.7 Hz) after the damage repair intervention. In a similar way, the peak amplitude, which increased after the earthquake, shows a significant reduction after the damage repair intervention. Changes in frequency and amplitude are both related to the variation of structural stiffness, since the mass had, instead, not changed. Considering the HVNSR functions for each component (longitudinal and transversal direction), it is noted that the decrease is evident only for the transversal HVNSR function (Figure 6 and Figure 7), in fact the cracks are mainly on the shorter side of the building. The drop is about of 24%, according to the value estimated by Vidal et al. (2013). On the contrary, the CFR block has the main frequency at about 3 Hz and it remains unchanged after the earthquake and after the damage repair intervention (Figure 6).

Figure 6 – HVNSR spectra acquired on STD side (left) and CFR side (right): a) before the earthquake; b) after the earthquake; c) after the damage repair.

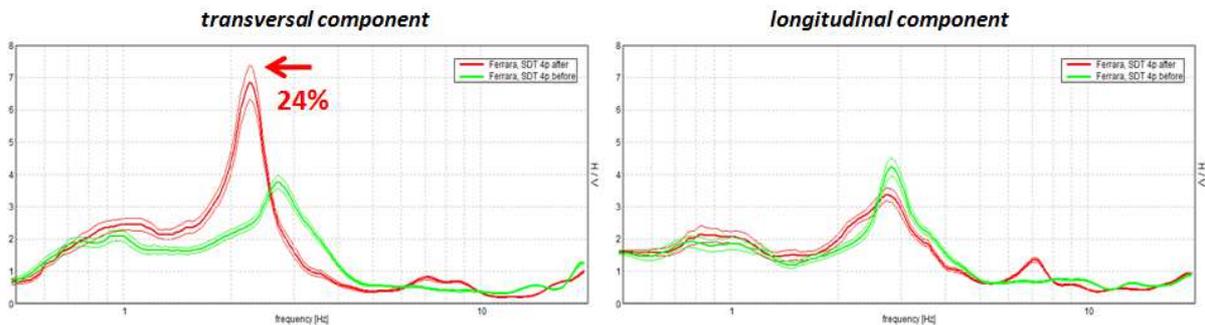
Figure 7 – HVNSRs acquired on STD side for the transversal component (left) and for the longitudinal component (right), before the earthquake (green line) and after the earthquake (red line).

First of all, the HVNSR estimated before the May 20 MI 5.9 earthquake both on the free-field close to the building and on the building, ensured that the structural frequency of the building is distinct enough from the soil's natural frequency. Subsequently, the HVNSRs estimated on the building before and after the May 20 MI 5.9 earthquake presented a permanent frequency drop from 2.9 Hz to 2.2 Hz only on the building side (STD) and only in the transversal direction which suffered slight damages

due to earthquake. The damage repair intervention was able to restore the natural frequency (2.7 Hz) nearly up to its original value. The obtained results suggest as:
